Hawkeye Home Inspections
www.HawkeyeHomeInspections.net
OCHI#265 WA#1493 CCB#225525 PH#503-341-3522 EMAIL
hawkeyeoregon@gmail.com

Inspection date: 04/20/2022 Inspector: Chris Bernhardt
Address: 1234 N 1st St Client: John Smith
Beaverton, OR 97007

Home Inspection Report

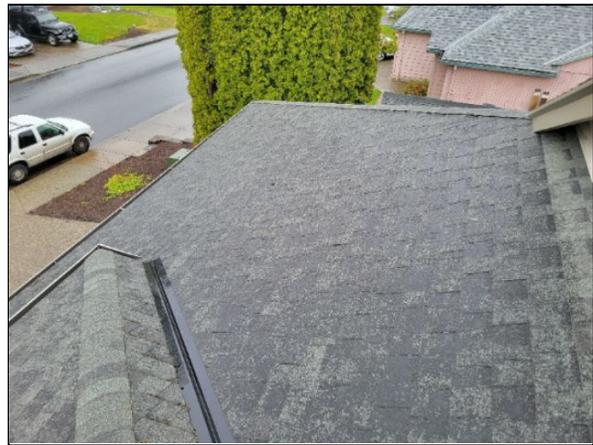
Old roof, leaks in multiple areas along left side predominantly

Has 2 layers. Has mold and moisture damage to roof sheathing where roof has been leaking.

Item 1.1 - Granule loss

- 1) Replace the roof.**
- 2) Remediate mold on roof decking not replaced during the reroofing.**

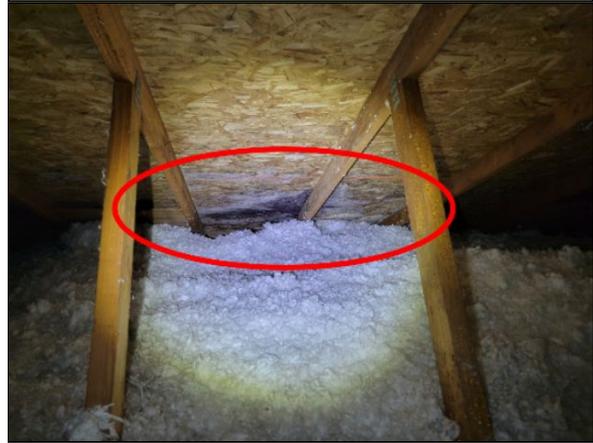
Item 1.5 - Mold and deterioration to OSB roof sheathing

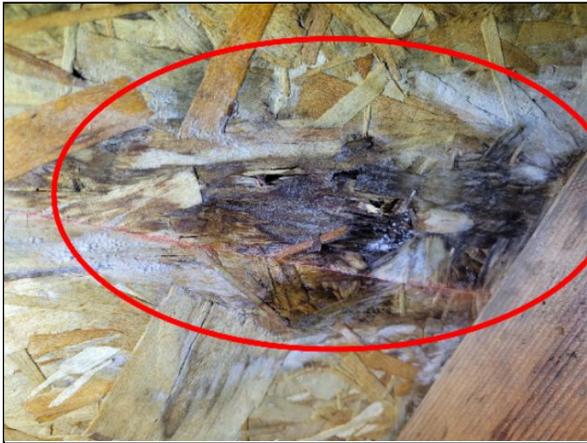
Item 1.6 - Mold and deterioration to OSB roof sheathing

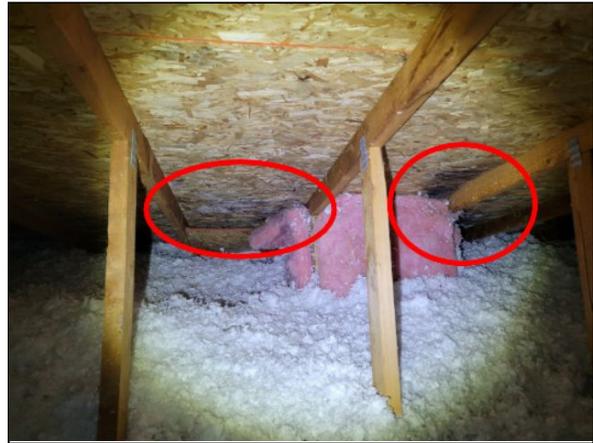
Item 1.7 - Mold and deterioration to OSB roof sheathing

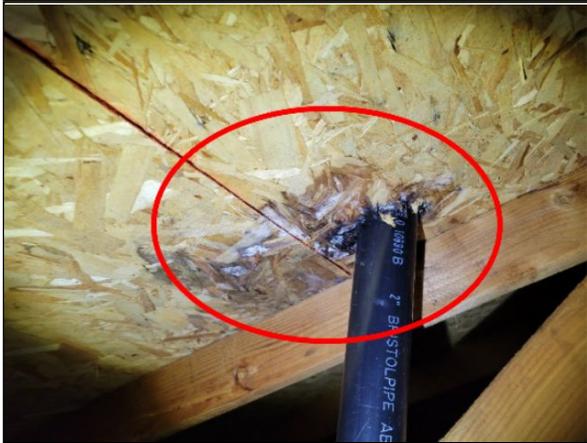
Item 1.8 - Mold and deterioration to OSB roof sheathing

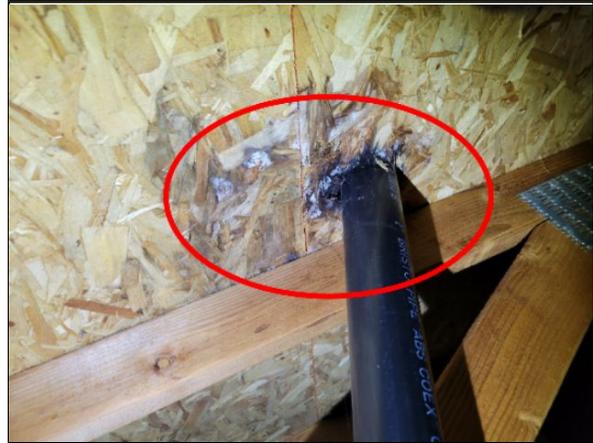
Item 1.9 - Old roof, leaks at some plumbing vents

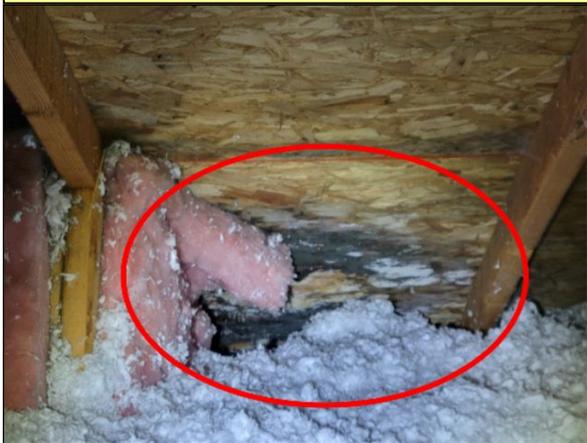
Item 1.10 - Old roof, leaks at some plumbing vents

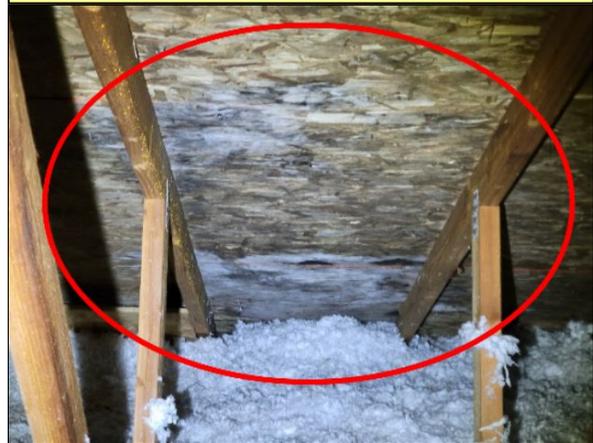
Item 1.11 - Mold and deterioration to OSB roof sheathing

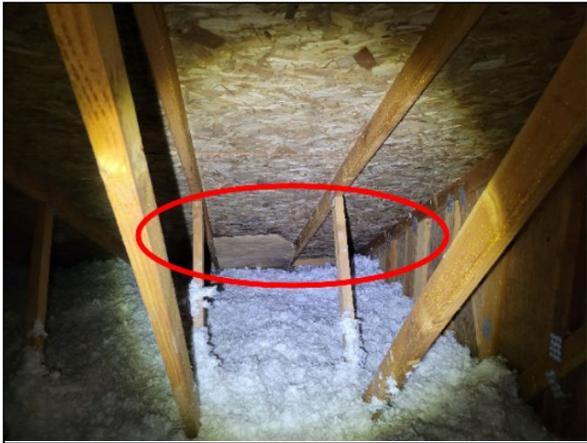
Item 1.12 - Mold and deterioration to OSB roof sheathing

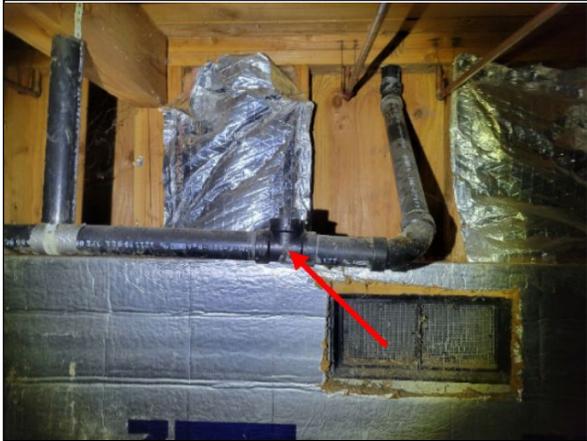
Bathtub drain leaking into crawlspace

Item 3.1 - Bathtub drain leaking into crawlspace.

- 3) Repair leaky bathtub drain.**

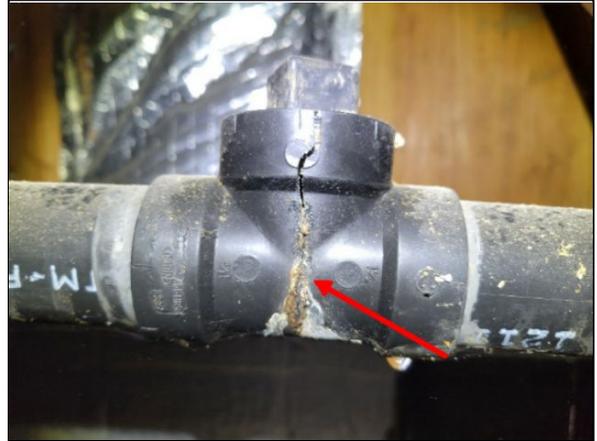
Cracked drainage fitting leaking in crawlspace

Item 4.1 - Cracked drainage fitting in crawlspace.

- 4) Have a plumber repair the cracked drainage fitting on the branch drain line indicated above.**

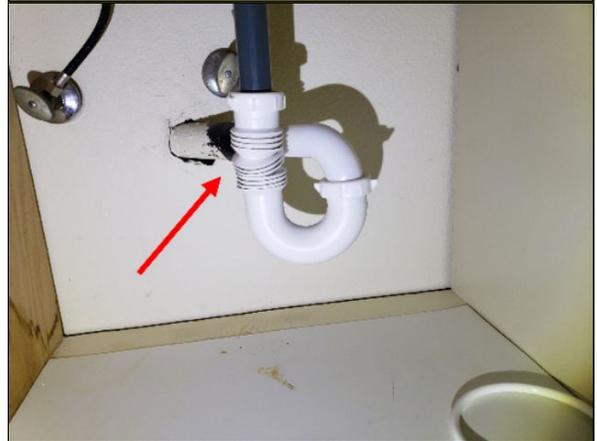
Trap arm to branch drain connection leaks

Item 5.1 - Trap arm to branch drain connection leaks: 1st sink in master bedroom bathroom.

- 5) Repair leaky drain connection indicated above.**

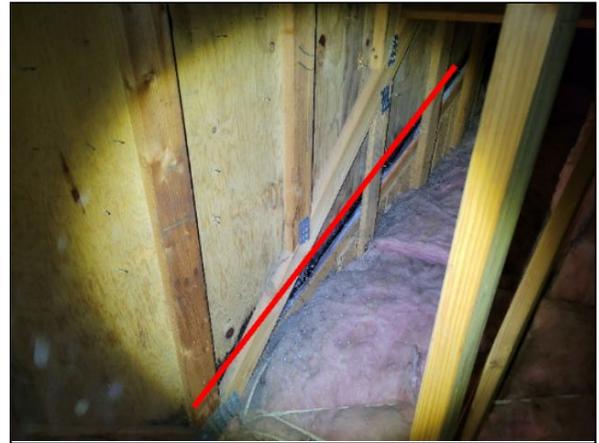
Rot/moisture damaged plywood wall sheathing

Item 7.1 - Rot/moisture damaged plywood wall sheathing.

7) Remove wall coverings, waterproofing etc. to the extent of the damage and replace damaged materials. Then re-waterproof, install new wall coverings and caulk and paint to match.
