Hawkeye Home Inspections
www.HawkeyeHomeInspections.net
OCHI#265 WA#1493 CCB#225525 PH#503-341-3522 EMAIL
hawkeyeoregon@gmail.com

Inspection date: 04/20/2022 Inspector: Chris Bernhardt
Address: 1234 N 1st St Client: John Smith
Beaverton, OR 97007

Home Inspection Report

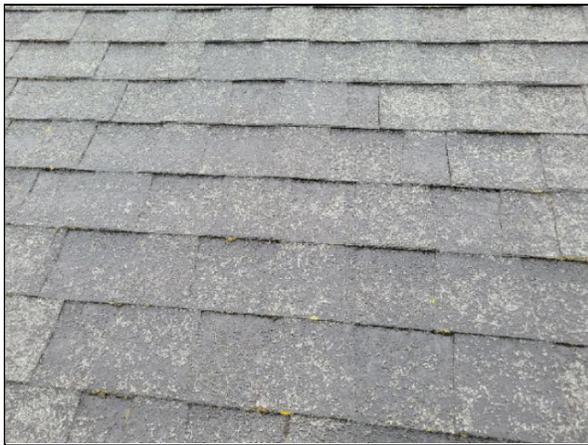
Old roof, leaks in multiple areas along left side predominantly

Item 1.1 - Granule loss

- 1) Replace the roof.**
- 2) Remediate mold on roof decking not replaced during the reroofing.**

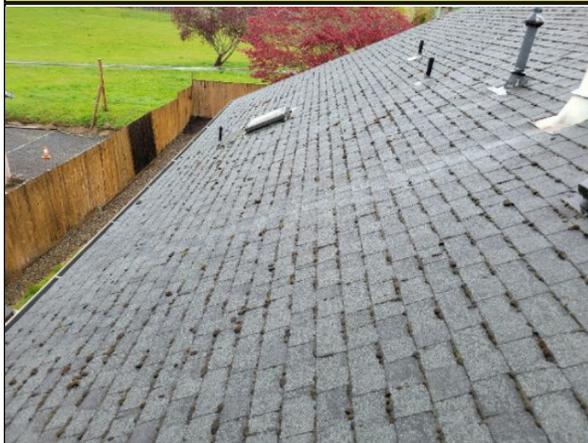
Item 1.3 - Moss buildup

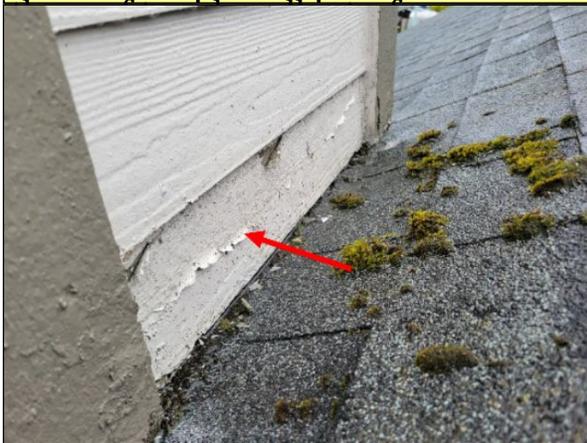
Item 8.2 - Split caulking on chimney chase, peeling paint.

8) Repair split caulking and peeling paint on the chimney chase.

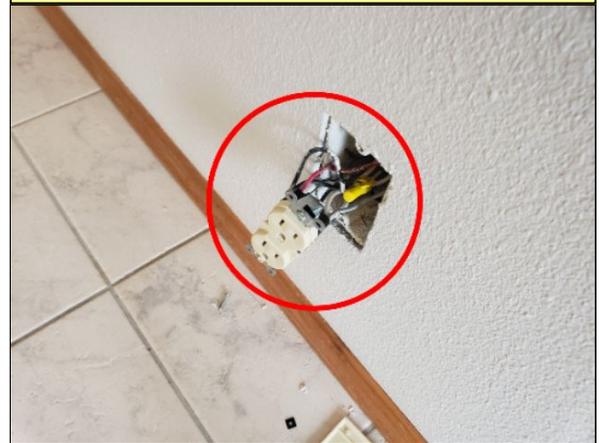
Safety hazard.

Item 9.1 - Receptacle hanging by wiring: One in family room.

9) Have an electrician make repairs.

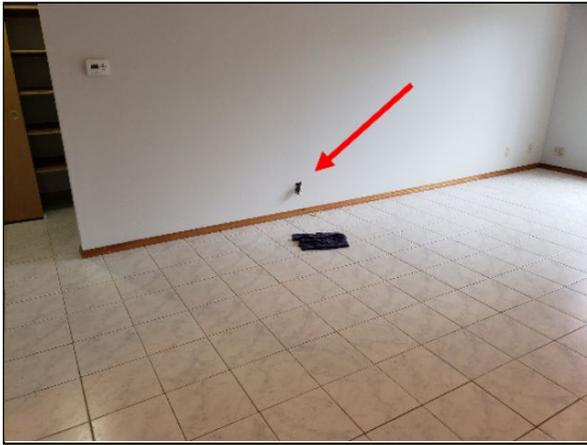
Item 9.2 - Receptacle hanging by wiring: One in family room.

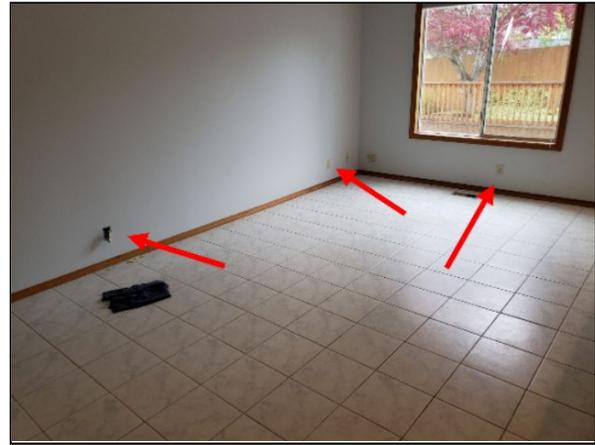
Item 10.1 - Dead receptacle: Family room.

10) Have an electrician repair non functioning receptacles indicated above.

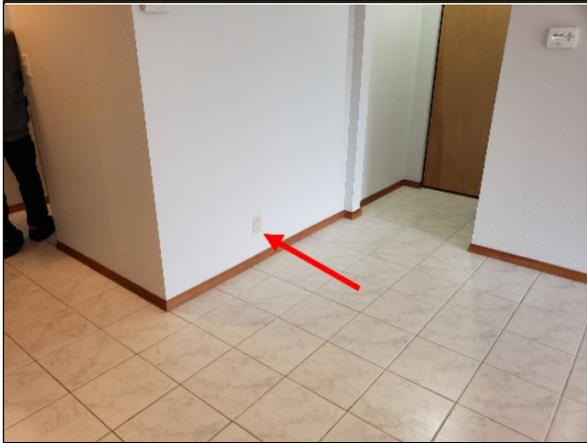
Item 10.2 - Dead receptacle: Family room.

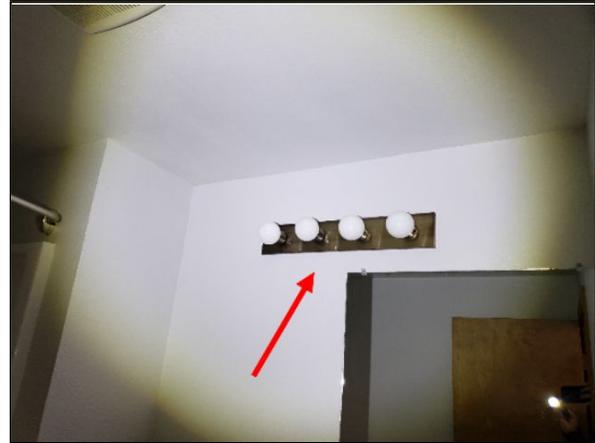
Item 11.1 - Light fixture not working: Hallway bathroom.

11) Have an electrician troubleshoot and repair.

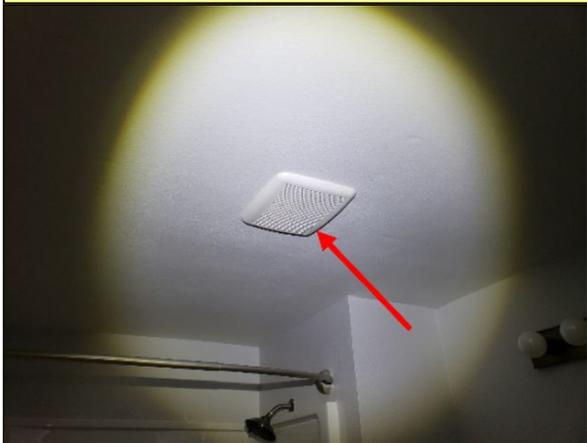
Item 12.1 - Bathroom exhaust fan not working: Hallway bathroom.

12) Repair or replace the bathroom exhaust fan/s not working in the locations indicated above.

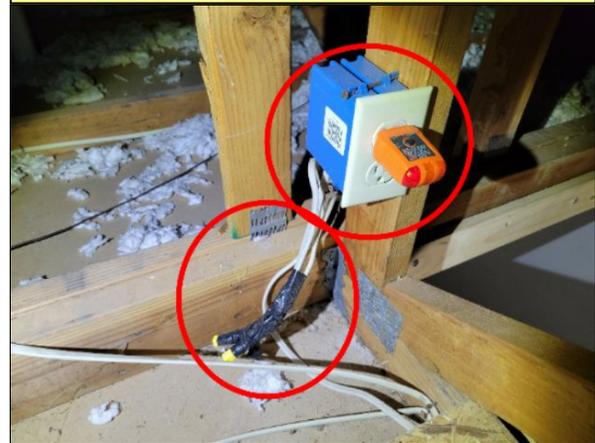
Improperly wired in receptacle

Item 13.1 - Improperly wired in receptacle: In attic over the garage.

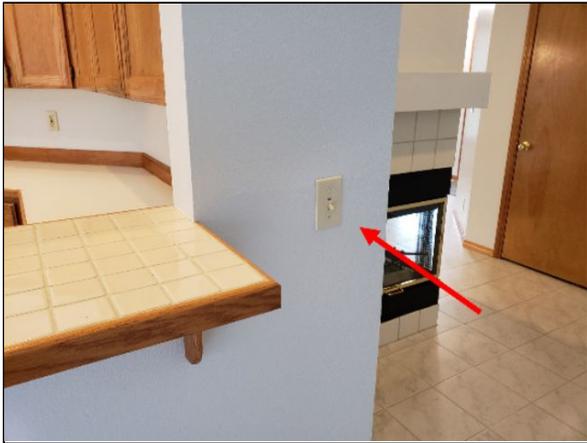
Item 14.1 - Mis-wired two way lighting circuit: For kitchen ceiling

14) Have an electrician repair the mis-wired two way lighting circuit/s at the locations above.

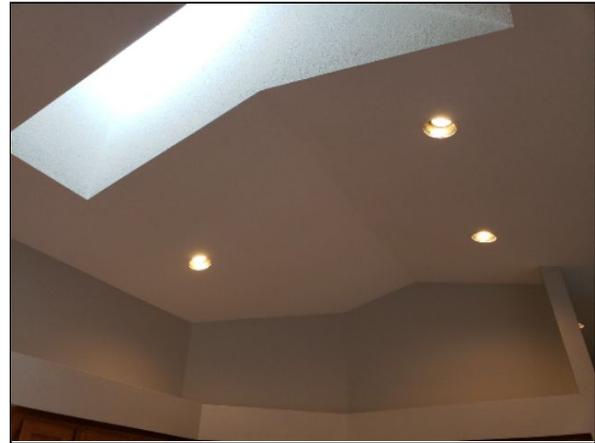
Item 14.2 - Mis-wired two way lighting circuit: For kitchen ceiling

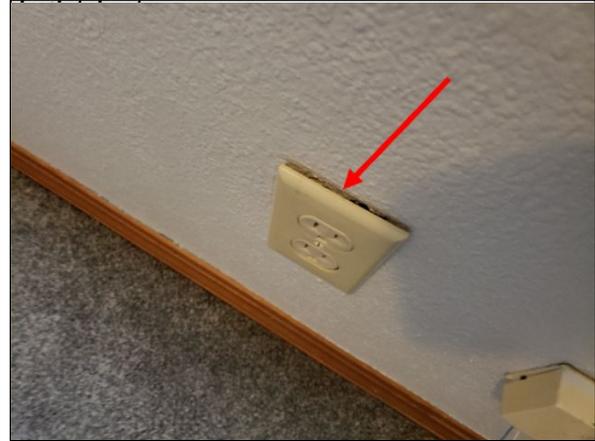
Loose receptacle

Item 15.1 - Loose receptacle: Under window in the 2nd bedroom.

15) Repair the loose receptacle or receptacles indicated above.

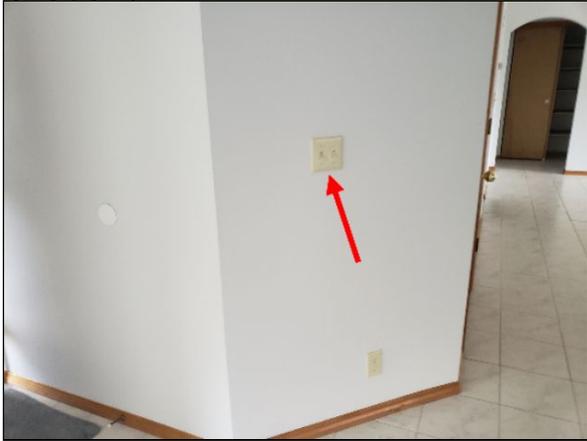
Item 16.1 - Unidentified wall switch purpose.

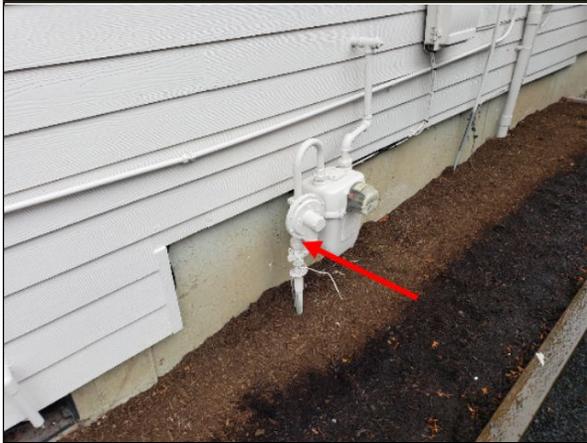
Item 20.1 - Odor of gas at the gas meter.

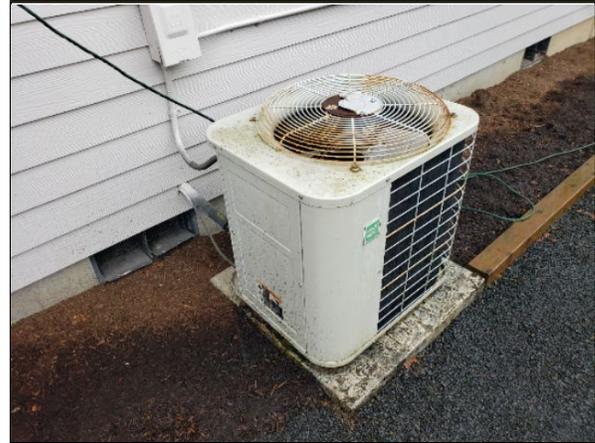
At temperatures below 65, I can't properly evaluate the performance of the A/C system. Running the compressor at low temps can even damage it.

Item 21.1 - Too cold to test A/C system.

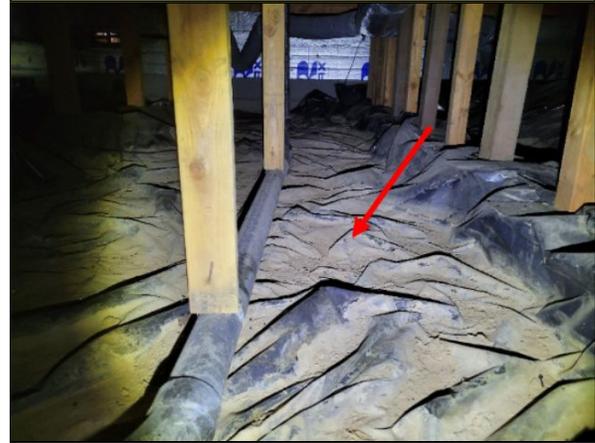
Indicates repeated water intrusion into the crawlspace. Professionally installed crawlspace drainage systems run anywhere from a few thousand dollars to \$10k and more. Anything over a few thousand dollars is overkill in our opinion in our area. Water intrusion causing problematic conditions

Item 23.1 - Silt on vapor barrier in crawlspace.

23) Evaluate over the next rainy season. If water doesn't drain away within a few days after rains, then install a drainage system. In most cases that will be a sump pump and trenching adjacent the foundation about a foot away on those sides if not all where water bleeds under the footer or thru joints and cracks in the foundation.

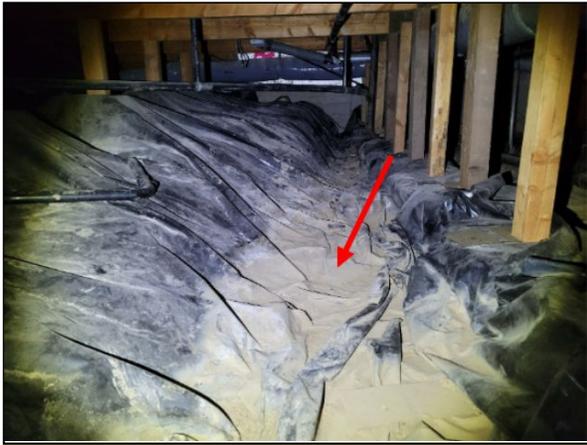
Item 23.2 - Silt on vapor barrier in crawlspace.

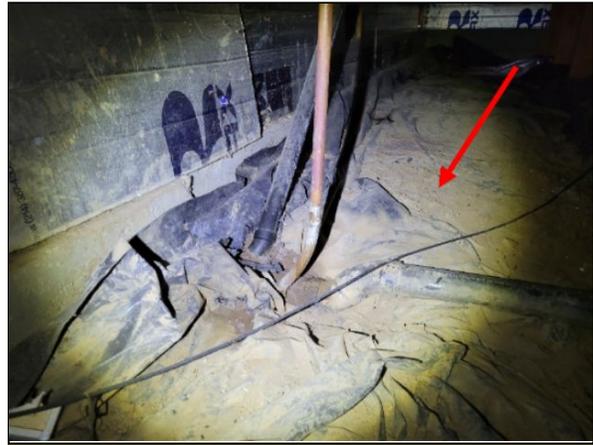
Item 23.3 - Silt on vapor barrier in crawlspace.

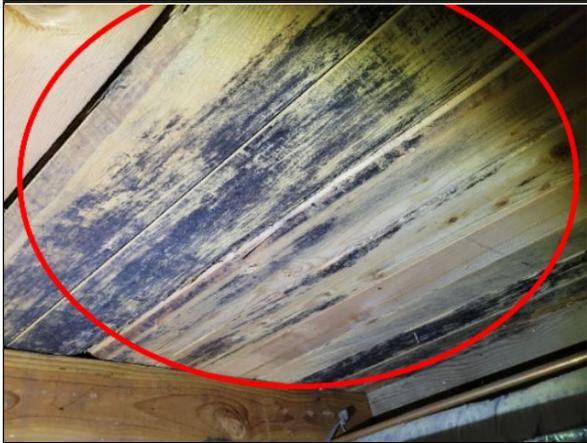
Mold that was already on the subflooring at the time the house was constructed. As long as the moisture content of the wood stays below 16%, the mold will remain inactive.

Item 24.1 - Lumber mold on beams in crawlspace.

24) If you want to remove the mold stains, bleach them with MMR or RMR-86.

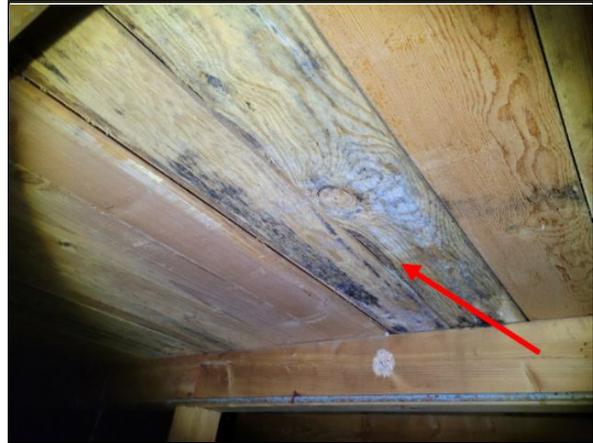
Item 24.2 - Lumber mold on subflooring in crawlspace.

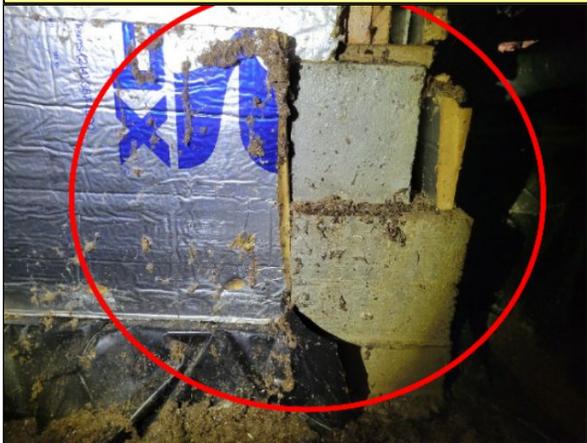
Item 25.1 - Carpenter Ant activity.

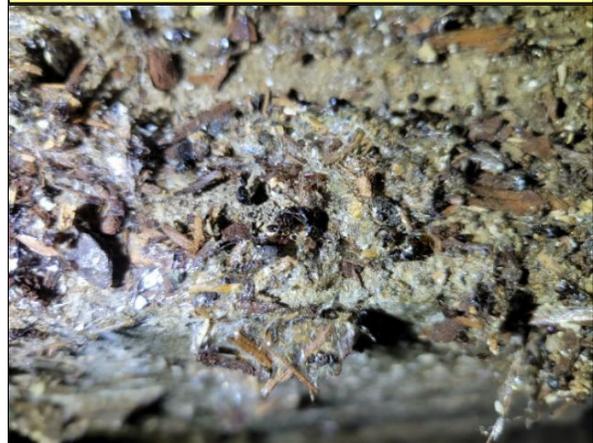
Item 25.2 - Carpenter Ant activity.

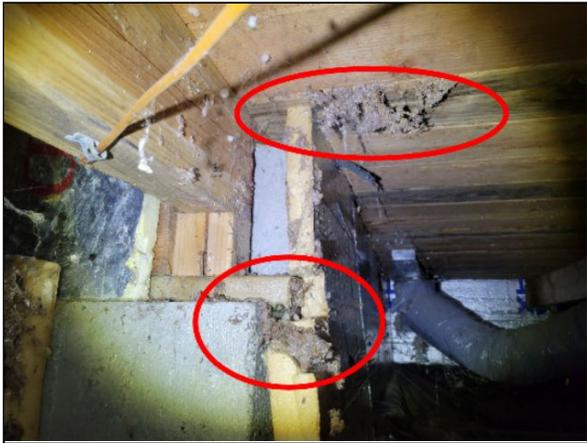
Item 25.3 - Carpenter Ant activity.

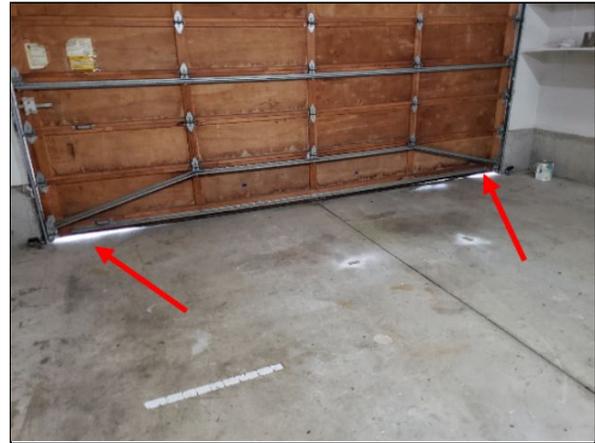
Item 26.1 - Daylight through garage door bottom seal.

26) Repair or replace garage bottom door seal.

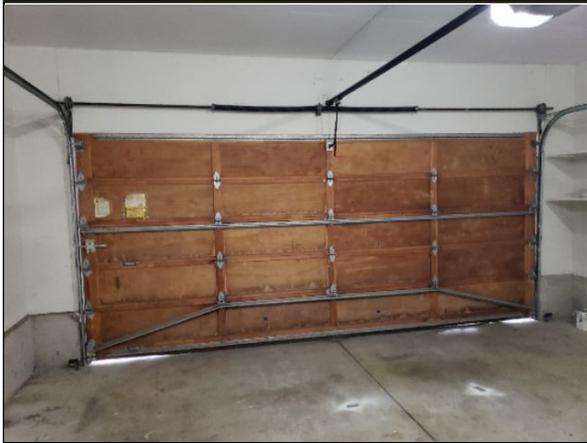
Item 27.1 - Unbalanced garage door.

27) Have a garage door contractor adjust or replace garage door springs.

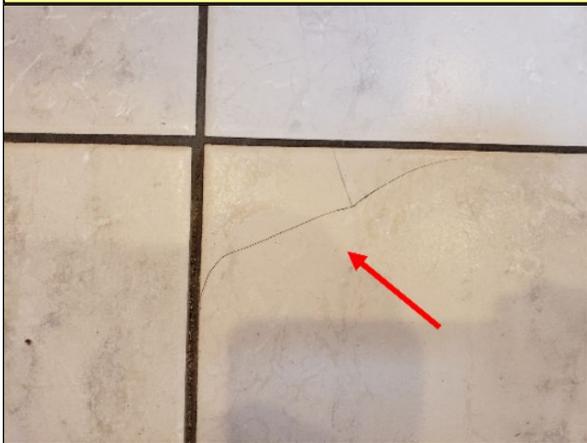
Some cracked floor tiles

Item 28.2 - Cracked floor tiles:
Kitchen.

28) Replace cracked floor tiles.

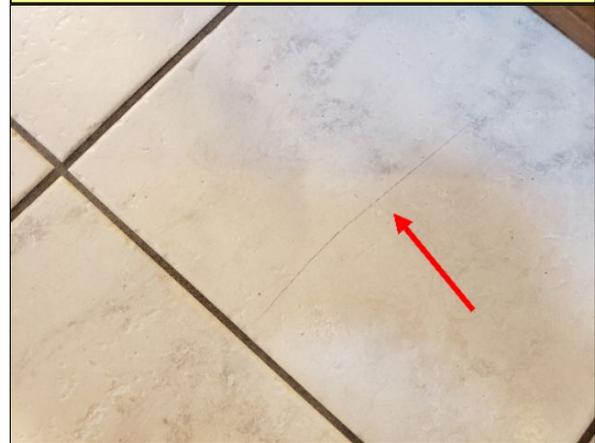
Item 28.3 - Cracked floor tiles:
Kitchen.

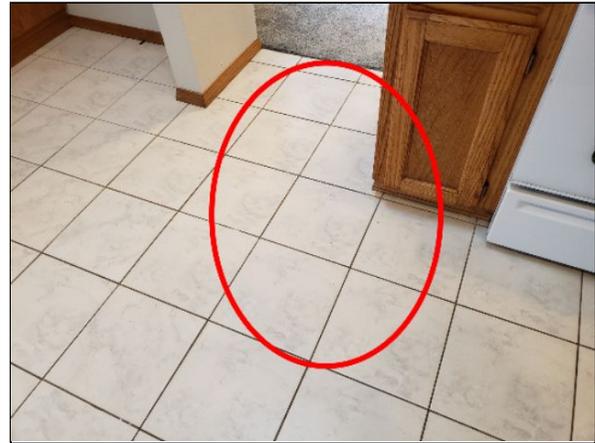
Item 28.4 - Cracked floor tiles:
Kitchen.

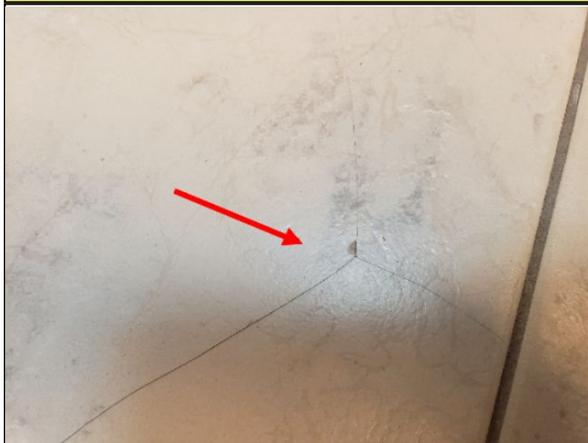
Item 28.5 - Cracked floor tiles:
Kitchen.

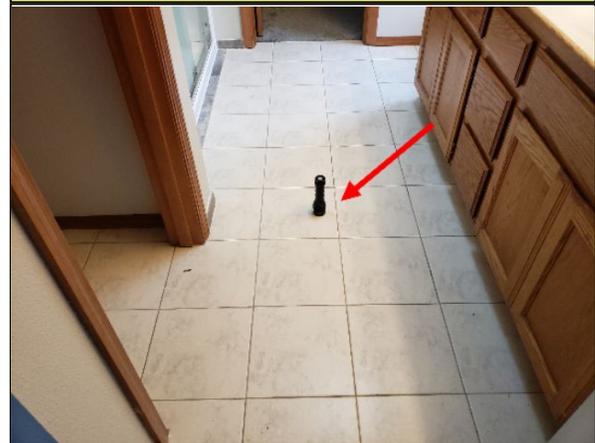
Item 28.6 - Cracked floor tiles: Master
bedroom bathroom.

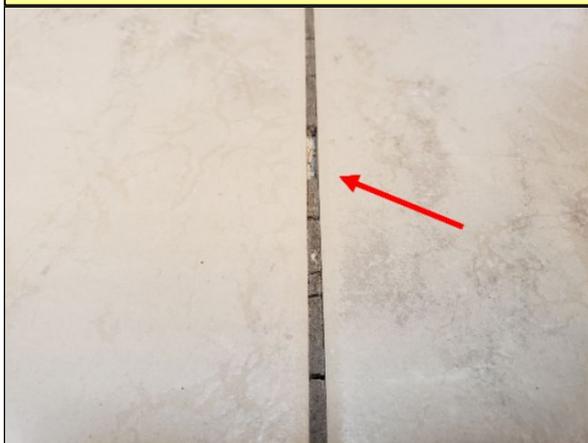
Item 28.7 - Some cracked floor tiles:
Master bedroom bathroom.

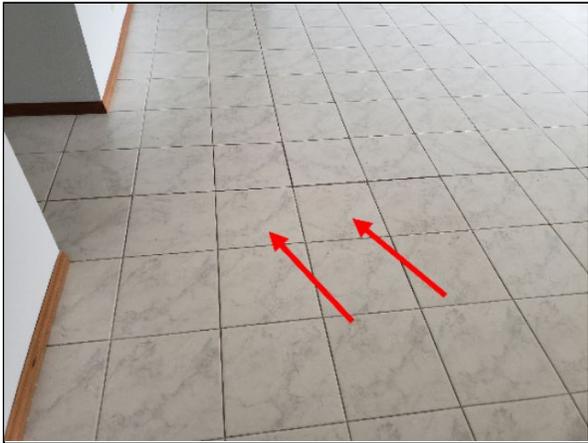
Item 29.2 - Popped grout floor tile
joint: Master bedroom bathroom.

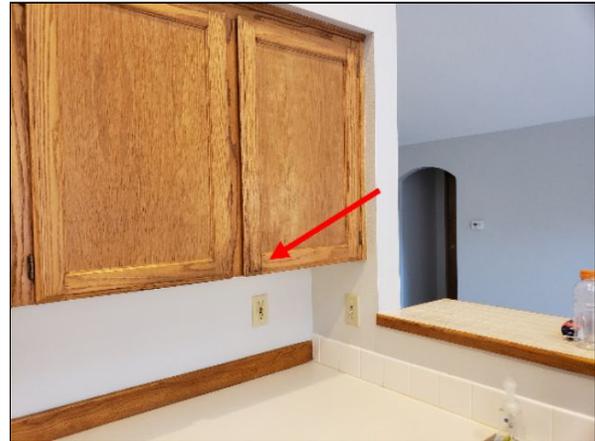
Item 36.1 - Joint separation in cabinet door.

36) Have cabinet door repaired.

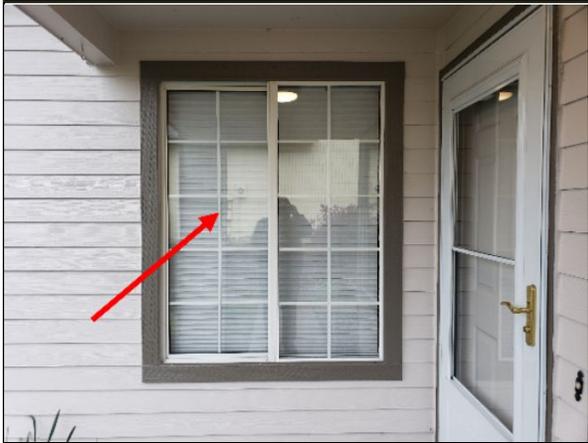
Window screens missing

Item 50.1 - Some window screens missing.

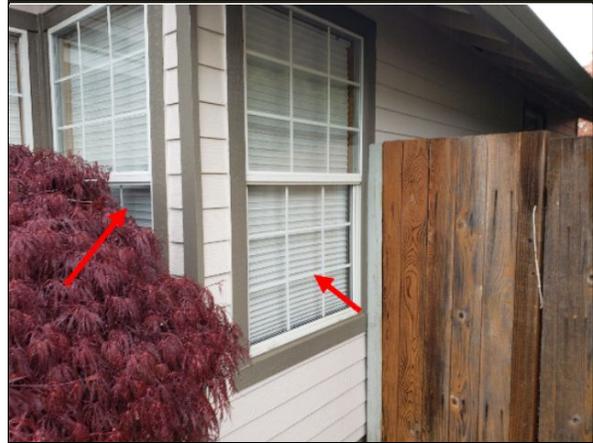
Item 50.2 - Some window screens missing.

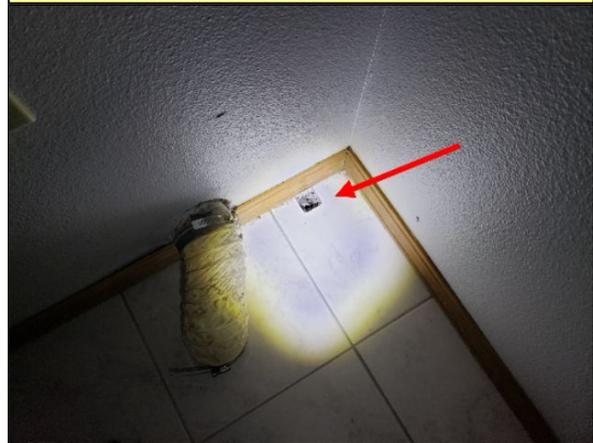
Item 51.1 - Abandoned gas line for a clothes dryer.
